SPANISH CREEK ASSESSMENT
REHABILITATION AND GRAVEL MANAGEMENT STRATEGY

Feather River Coordinated Resource Management Group
April 2006

SPANISH CREEK ASSESSMENT REHABILITATION AND GRAVEL MANAGEMENT STRATEGY

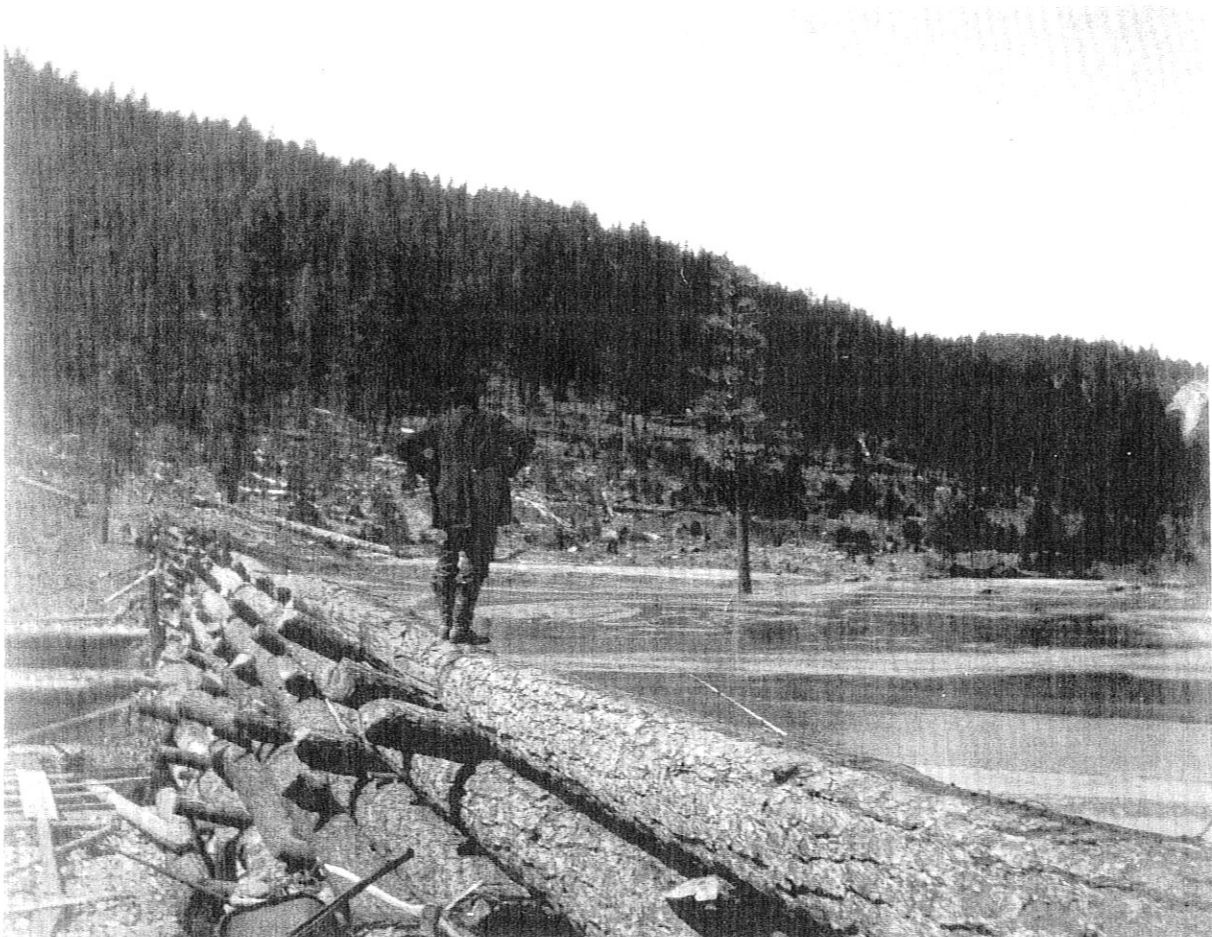
Figure 5. Sediment Deposit Behind Log Crib Dam at Green's Flat

After the passage of the Sawyer Decision in 1884, hydraulic outwash material was collected behind large log-crib dams (Figure 5) that have since deteriorated, releasing

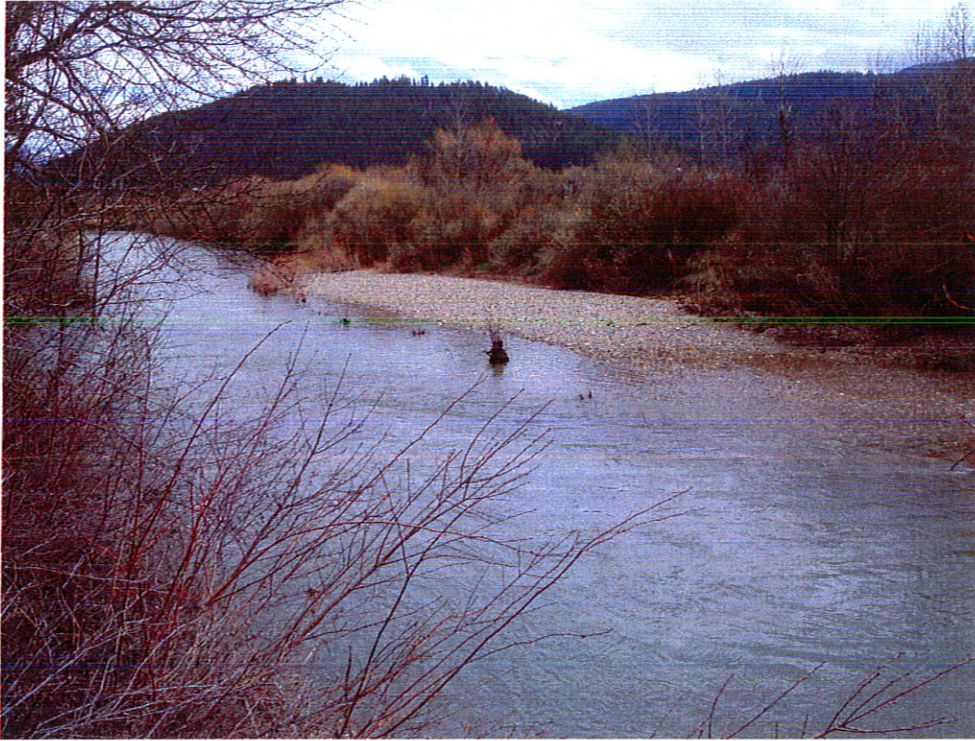
Figure 6. Channel Bend and Point Bar

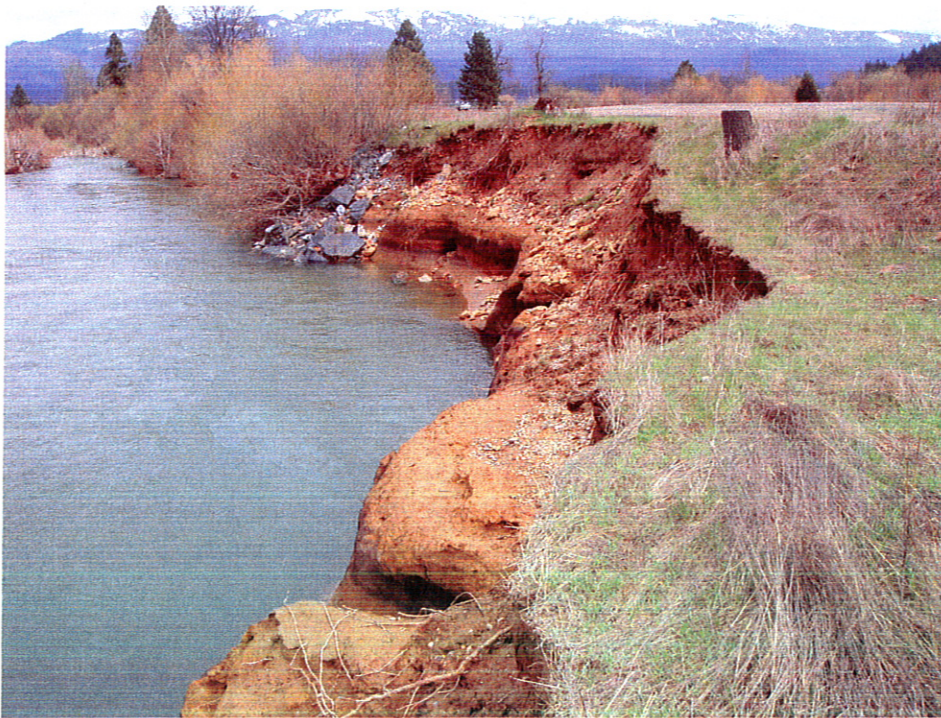
Figure 7. Exposed Lakebeds and Alluvial Sediment in American Valley

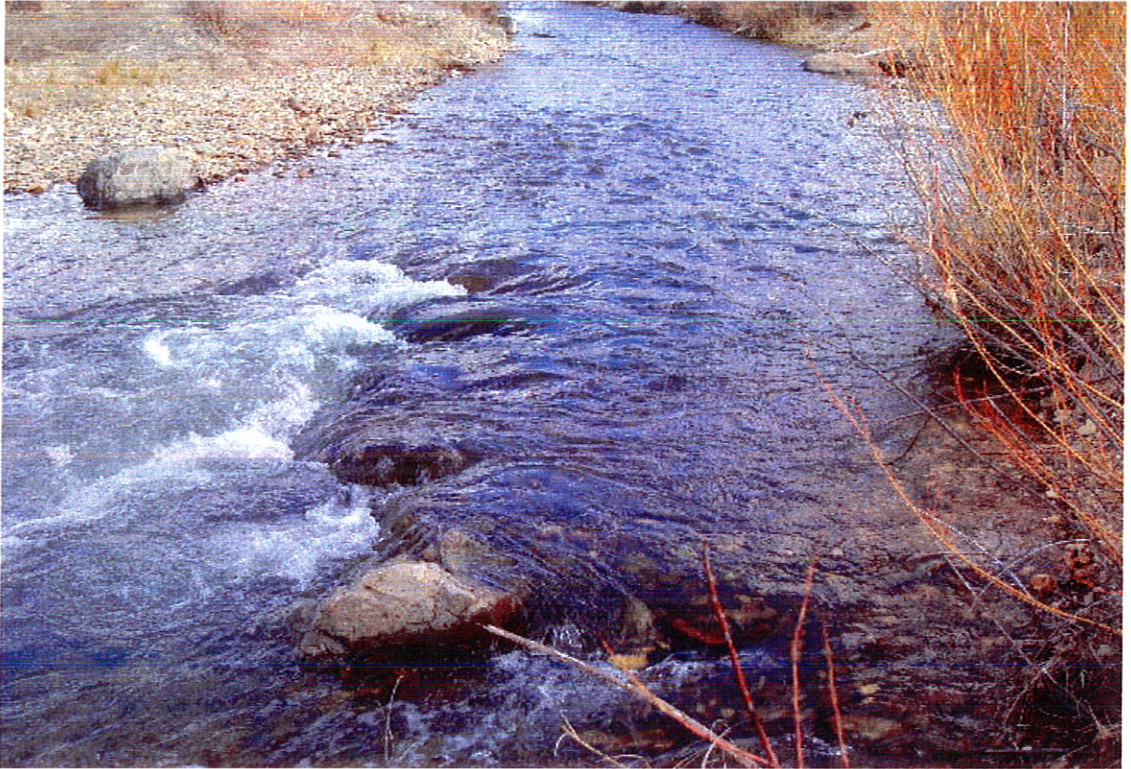
Figure 8. Boulder Vane

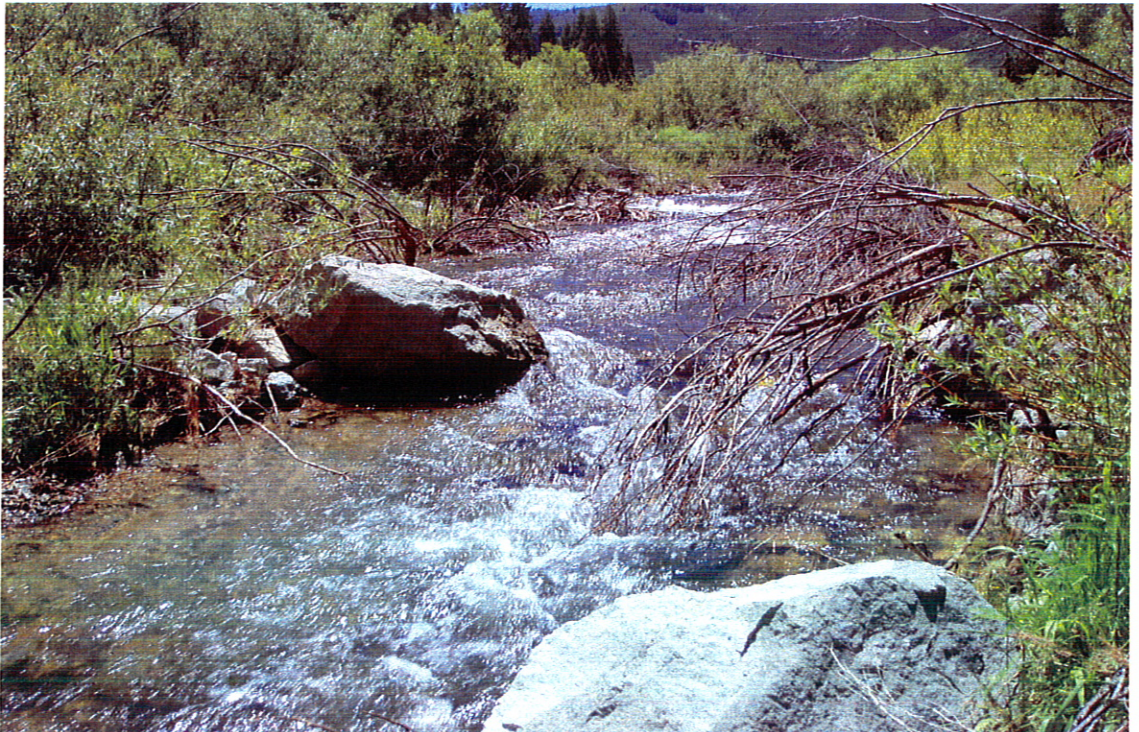
Figure 9. Boulder Channel Constriction

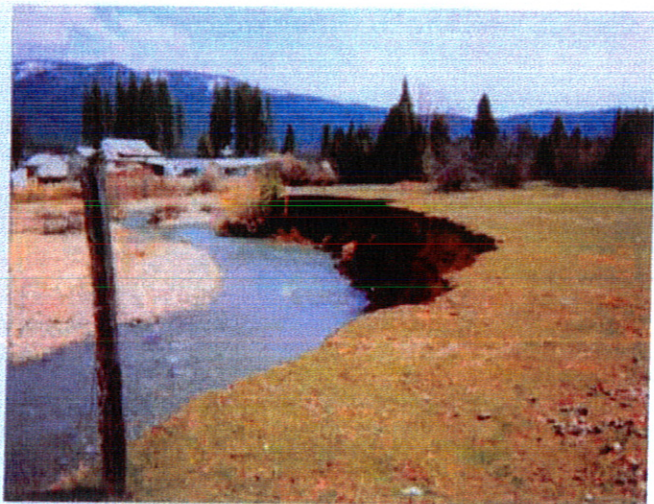
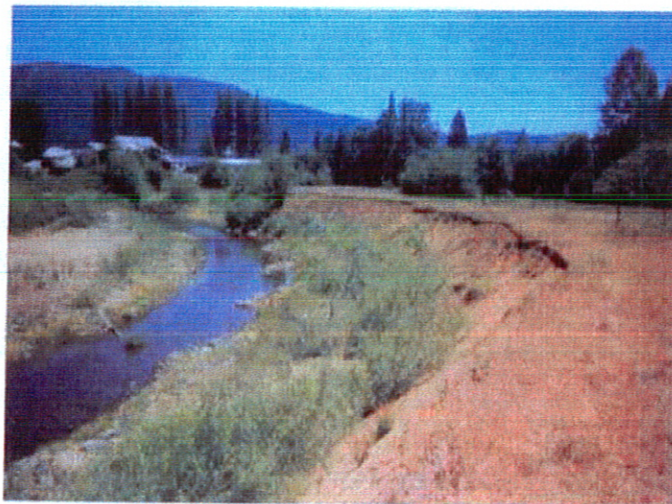
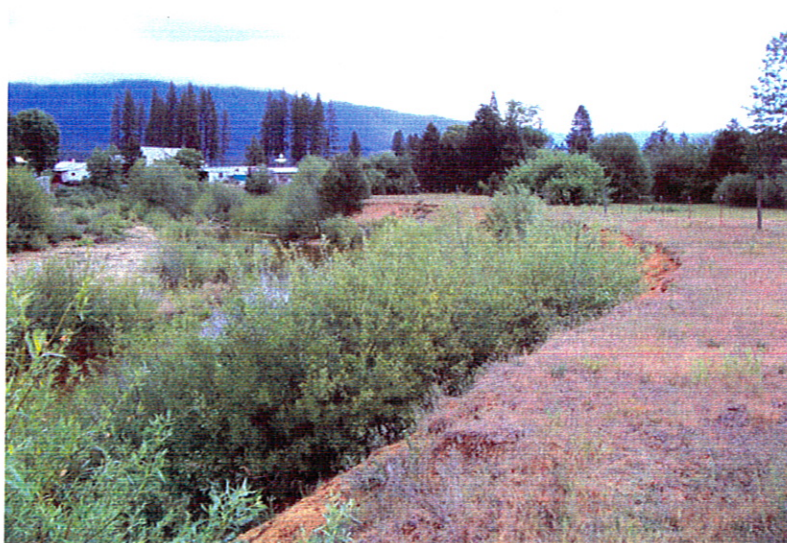
Figure 10. Bank Treated with Boulder Vanes, Sloped Back and Vegetated

1 *Pre-project, Wolf Creek 1999*

2 *Post-project, Wolf Creek 2000*

3 *Wolf Creek 2004*

Again, these techniques include a lot of vegetation plantings. Vertical banks would also be laid back and vegetated, as shown in Figure 10. Along with a dense mat of roots to help stabilize banks, vegetation creates a dense layer of stems against the banks,

eliminating most bare soil areas, reducing flood flow velocities along the treated banks to near zero, and stabilizing the steeply sloped soil mass with deep roots.
